ALCANTARA WIND FARM PROVINCE OF MESSINA, SICILY TECHNICAL DUE DILIGENCE ON FOUNDATIONS OF SELECTED WTGs

106714 ALCANTARA WIND FARM, Province of Messina, Sicily, Italy

REPORT - Date: 2013-11-30

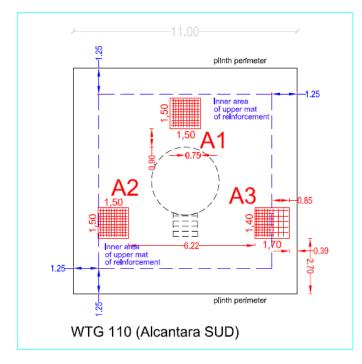
## Fig. 2-Ea WTG 110

- 2 no. layers of 24 mm diameter bars (measured by gauge) were observed, positioned at 125 mm - A1: centre distance on both layers (A1 was all in inner area of upper mat of reinforcement);
- 2 no. layers of 24 mm diameter bars (measured by gauge) were observed, positioned at 125 mm - A2: centre distance on both layers (A2 was all in inner area of upper mat of reinforcement);
- 2 no. layers of 24 mm diameter bars (measured by gauge) were observed, spacing changed from 125 mm to 250 mm centre distance because A3 contained the both the inner and outer area of upper mat reinforcement).

- re-bars in compliance with design (please refer to Chapter 2)
- quality of workmanship: very good.

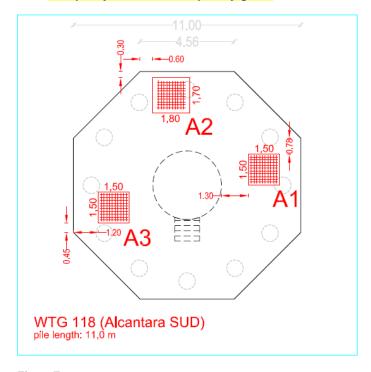
#### Fig. 2-F WTG 118

- A1: 2 no. layers of 24 mm diameter bars (measured by gauge) were observed, positioned at 135 mm centre distance on both layers (measured by gauge);
- A2: 2 no. layers of 24 mm diameter bars (measured by gauge) were observed, positioned at 135 mm centre distance on both layers (measured by gauge);
- **A3:** 2 no. layers of 24 mm diameter bars (measured by gauge) were observed, positioned at 135 mm centre distance on both layers (measured by gauge).

- re-bars in compliance with design (please refer Chapter 2)
- quality of workmanship: very good.

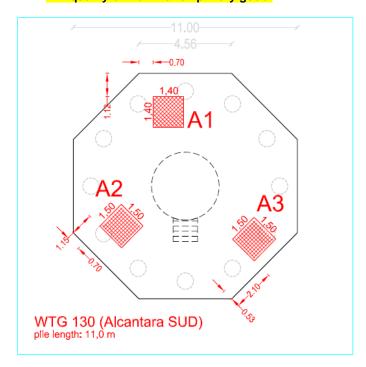
## Fig. 2-G WTG 130

- A1: 2 no. layers of 24 mm diameter bars (measured by gauge) were observed, positioned at 135 mm centre distance on both layers (measured by gauge);
- A2: 2 no. layers of 24 mm diameter bars (measured by gauge) were observed, positioned at 135 mm centre distance on both layers (measured by gauge);
- **A3:** 2 no. layers of 24 mm diameter bars (measured by gauge) were observed, positioned at 135 mm centre distance on both layers (measured by gauge).

re-bars in compliance with design (please refer to Chapter 2) quality of workmanship: very good.

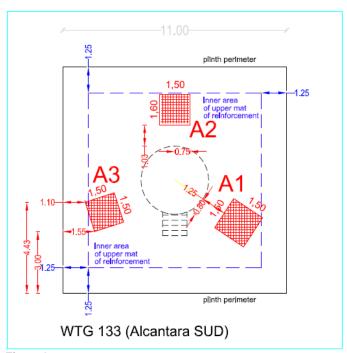
Fig. 2-Ga WTG 133

- A1: 2 no. layers of 24 mm diameter bars (measured by gauge) were observed, positioned at 125 mm centre distance on both layers (A1 was all in inner area of upper mat of reinforcement);
- **A2:** 2 no. layers of 24 mm diameter bars (measured by gauge) were observed, positioned at 125 mm centre distance on both layers (A2 was all in inner area of upper mat of reinforcement);
- **A3:** 2 no. layers of 24 mm diameter bars (measured by gauge) were observed, positioned at 125 mm centre distance on both layers (A3 was all in inner area of upper mat of reinforcement).

re-bars in compliance with design (please refer to Chapter 2) quality of workmanship: very good.

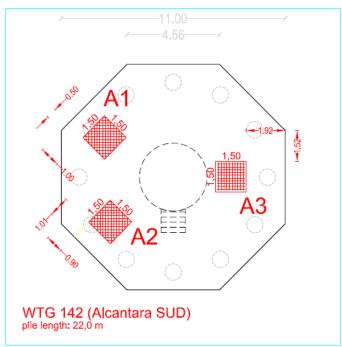
## Fig. 2-H WTG 142

- A1: 2 no. layers of 24 mm diameter bars (measured by gauge) were observed, positioned at 135 mm centre distance on both layers (measured by gauge);
- A2: 2 no. layers of 24 mm diameter bars (measured by gauge) were observed, positioned at 135 mm centre distance on both layers (measured by gauge);
- A3: 2 no. layers of 24 mm diameter bars (measured by gauge) were observed, positioned at 135 mm centre distance on both layers (measured by gauge).

re-bars in compliance with design (please refer to Chapter 2) quality of workmanship: very good.

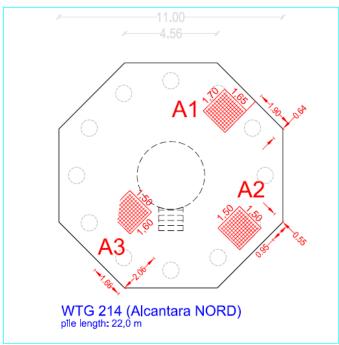
Fig. 2-I WTG 214

- A1: 2 no. layers of 24 mm diameter bars (measured by gauge) were observed, positioned at 135 mm centre distance on both layers (measured by gauge);
- **A2:** 2 no. layers of 24 mm diameter bars (measured by gauge) were observed, positioned at 135 mm centre distance on both layers (measured by gauge);
- **A3:** 2 no. layers of 24 mm diameter bars (measured by gauge) were observed, positioned at 135 mm centre distance on both layers (measured by gauge).

re-bars in compliance with design (please refer to Chapter 2) quality of workmanship: very good.

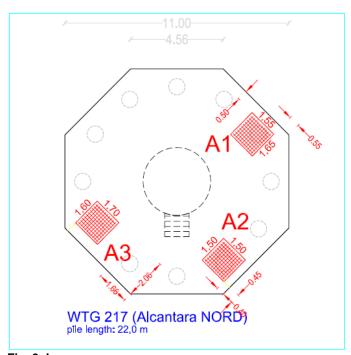
Fig. 2-J WTG 217

- A1: 2 no. layers of 24 mm diameter bars (measured by gauge) were observed, positioned at 135 mm centre distance on both layers (measured by gauge);
- A2: 2 no. layers of 24 mm diameter bars (measured by gauge) were observed, positioned at 135 mm centre distance on both layers (measured by gauge);
- A3: 2 no. layers of 24 mm diameter bars (measured by gauge) were observed, positioned at 135 mm centre distance on both layers (measured by gauge).

re-bars in compliance with design (please refer to Chapter 2) quality of workmanship: very good.

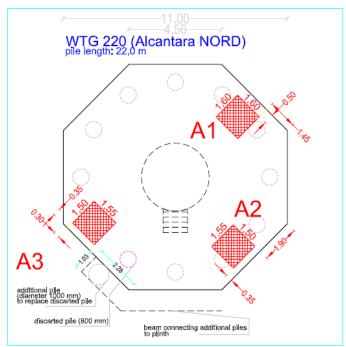
Fig. 2-K WTG 220

- A1: 2 no. layers of 24 mm diameter bars (measured by gauge) were observed, positioned at 135 mm centre distance on both layers (measured by gauge);
- A2: 2 no. layers of 24 mm diameter bars (measured by gauge) were observed, positioned at 135 mm centre distance on both layers (measured by gauge);
- A3: 2 no. layers of 24 mm diameter bars (measured by gauge) were observed, positioned at 135 mm centre distance on both layers (measured by gauge).

re-bars in compliance with design (please refer to Chapter 2) quality of workmanship: very good.

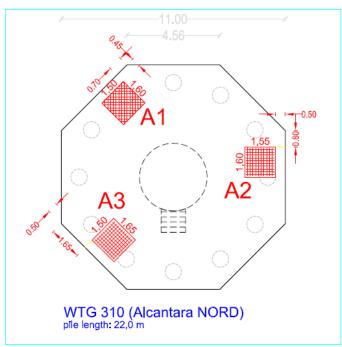
Fig. 2-L WTG 310

- A1: 2 no. layers of 24 mm diameter bars (measured by gauge) were observed, positioned at 135 mm centre distance on both layers (measured by gauge);
- A2: 2 no. layers of 24 mm diameter bars (measured by gauge) were observed, positioned at 135 mm centre distance on both layers (measured by gauge);
- 2 no. layers of 24 mm diameter bars (measured by gauge) were observed, - A3: positioned at 135 mm centre distance on both layers (measured by gauge).

re-bars in compliance with design (please refer to Chapter 2) quality of workmanship: very good.

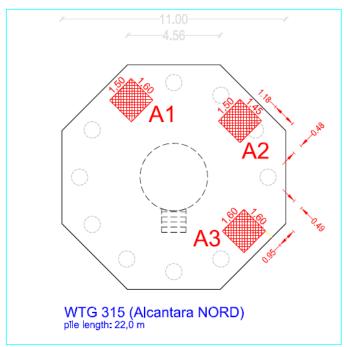
#### Fig. 2-M WTG 315

- A1: 2 no. layers of 24 mm diameter bars (measured by gauge) were observed, positioned at 135 mm centre distance on both layers (measured by gauge);
- A2: 2 no. layers of 24 mm diameter bars (measured by gauge) were observed, positioned at 135 mm centre distance on both layers (measured by gauge);
- A3: 2 no. layers of 24 mm diameter bars (measured by gauge) were observed, positioned at 135 mm centre distance on both layers (measured by gauge).

re-bars in compliance with design (please refer to Chapter 2) quality of workmanship: very good.

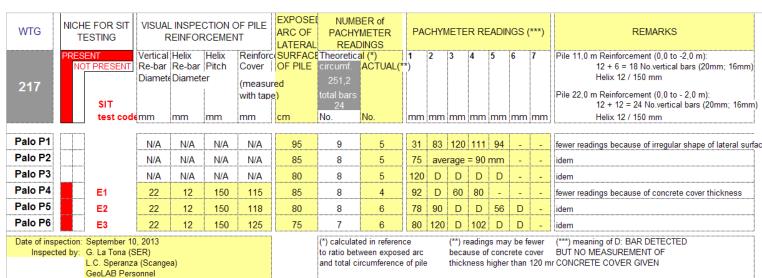
WTG 217
Pachymeter Readings

Piles exposed with excavation: P1, P2, P3, P4, P5, P6 Piles where SIT test was performed: E1, E2, E3

Pile selected for PS test: P5 = E2

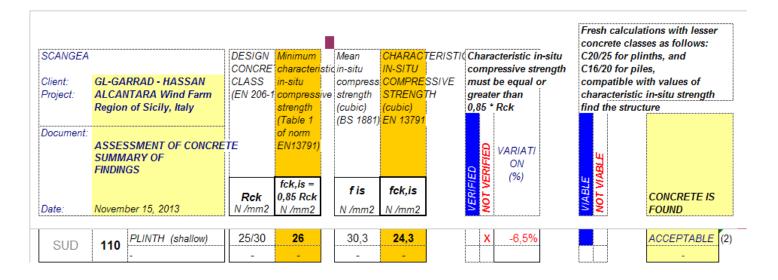
Calculations of characteristic in-situ compressive strength yield a result of 24,3 N/mm2, which is less (by 6,5%) than the minimum value specified by EN 13791 for C25/30 concrete ( 26 N/mm2). Please refer to chart below.

However, foundation stability re-calculated with concrete class C20/25 for the plinth (minimum characteristic in-situ strength = 21,0 N/mm2, which is less than 24,3 N/mm2), is found viable. Calculations are given in Appendix A of Annex 1 to this document, dedicated to WTG 110.

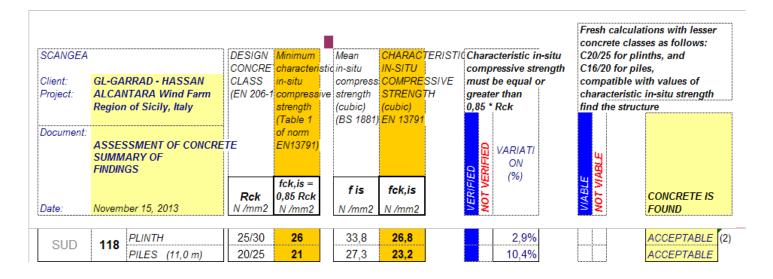
Calculations of characteristic in-situ compressive strength yield a result of 23,2 N/mm2, which is higher (by 10,4%) than the minimum value specified by EN 13791 for C20/25 concrete (21 N/mm2). Please refer to chart below.

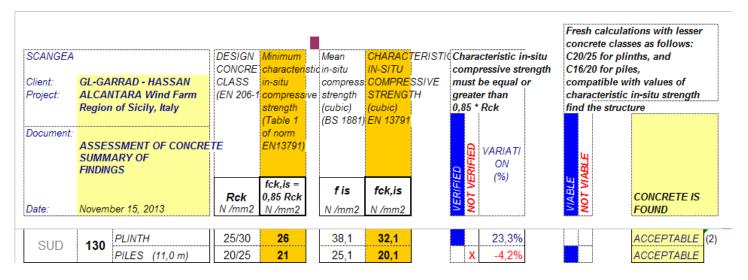
Calculations of characteristic in-situ compressive strength yield a result of 20,1 N/mm2, which is less (by 4,2%) than the minimum value specified by EN 13791 for C20/25 concrete ( 21 N/mm2).

However, foundation stability re-calculated with concrete class C16/20 for piles (minimum characteristic in-situ strength = 17,0 N/mm2, which is less than 20,1 N/mm2), is found viable. Calculations are given in Appendix A of Annex 3 to this document., dedicated to WTG 130

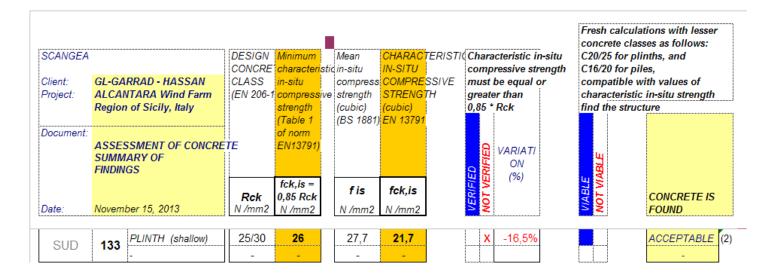
Calculations of characteristic in-situ compressive strength yield a result of 21,7 N/mm2, which is less (by 16,5%) than the minimum value specified by EN 13791 for C25/30 concrete ( 26 N/mm2). Please refer to chart below.

However, foundation stability re-calculated with concrete class C20/25 for the plinth (minimum characteristic in-situ strength = 21,0 N/mm2, which is less than 24,3 N/mm2), is found viable. Calculations are given in Appendix A of Annex IV to this document, dedicated to WTG 133.

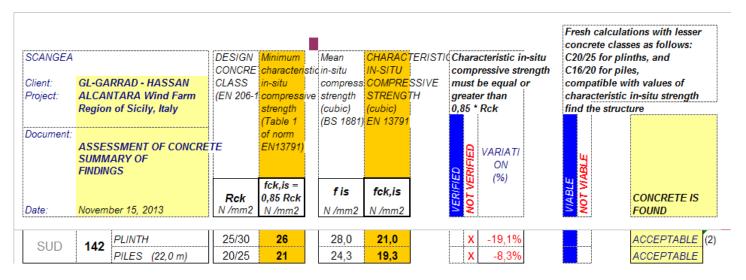
Calculations of characteristic in-situ compressive strength yield a result of 19,3 N/mm2, which is less (by 8,3%) than the minimum value specified by EN 13791 for C20/25 concrete (21 N/mm2).

However, foundation stability re-calculated with concrete class C16/20 for piles (minimum characteristic in-situ strength = 17,0 N/mm2, which is less than 20,1 N/mm2), is found viable. Calculations are given in Appendix A of Annex V to this document., dedicated to WTG 142.

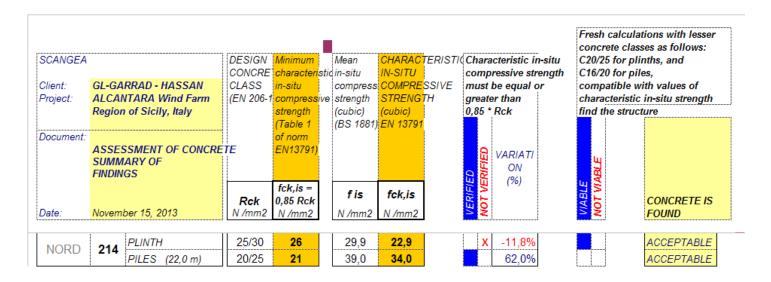
Calculations of characteristic in-situ compressive strength yield a result of 34,0 N/mm2, which is higher (by 62,0%) than the minimum value specified by EN 13791 for C20/25 concrete (21 N/mm2). Please refer to chart below.

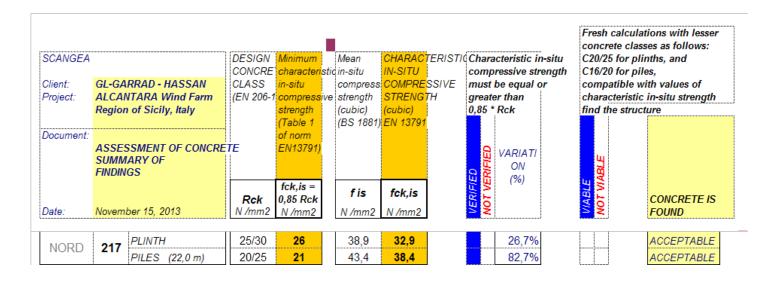
Calculations of characteristic in-situ compressive strength yield a result of 38,4 N/mm2, which is higher (by 82,7%) than the minimum value specified by EN 13791 for C20/25 concrete (21 N/mm2). Please refer to chart below.

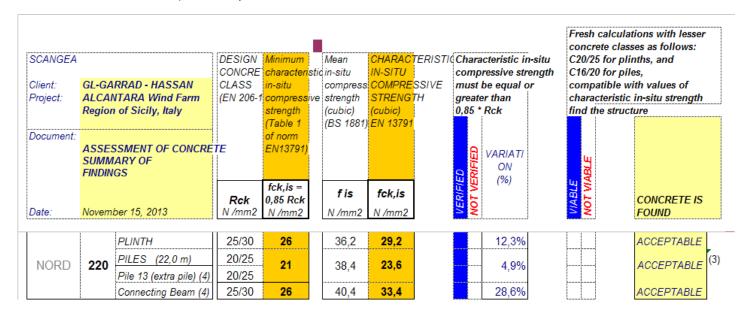
Calculations of characteristic in-situ compressive strength yield a result of **23,6 N/mm2**, which is higher (by 4,9%) than the minimum value specified by EN 13791 for C20/25 concrete ( 21 N/mm2). Please refer to chart below.

It is noteworthy that specimens initially obtained from pile P4, i.e. "220-P4-EST" and "220-P4-INT" failed at 10,71 N/mm2 and 11,99 N/mm2 respectively. Furthermore, pile P4 (please refer to foundation plan in Annex VIII, dedicated to WTG 220) is adjacent to a pile which was found defective, during construction, by the Owner's Engineer (Direttore dei Lavori). These very low values were accounted for in calculating the specimens' mean in-situ compressive strength, but were excluded from the calculation of the characteristic in-situ compressive strength because, based on the results from 3 no. additional cores taken from same pile P4, they were deemed to be the effect of a localized concrete defect.

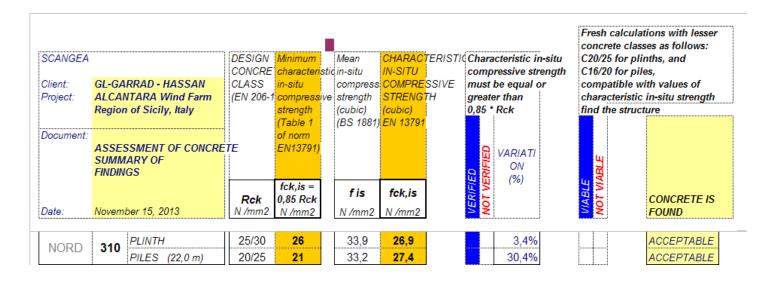
Calculations of characteristic in-situ compressive strength yield a result of 27,4 N/mm2, which is higher (by 30,4%) than the minimum value specified by EN 13791 for C20/25 concrete (21 N/mm2). Please refer to chart below.

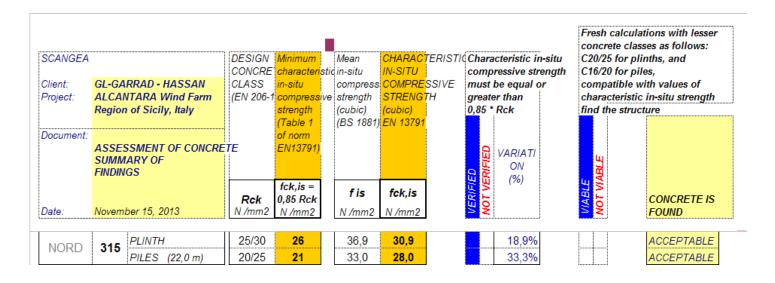
Calculations of characteristic in-situ compressive strength yield a result of 28,0 N/mm2, which is higher (by 33,3%) than the minimum value specified by EN 13791 for C20/25 concrete (21 N/mm2). Please refer to chart below.
